Southern Ute Indian Tribe

Pipeline Abandonment Inspection Form

Inspector: John Doe, SUIT DOE Environmental Compliance Specialist jdoe@sudoe.us Office #: 970-563-5544, Cell #: 970-769-8795		Date Inspected: 05/25/21		Operator: ACME Energy Co. Attendees: SUIT DOE, SUIT DNR	
Lease #: 750-88-1234		Pipeline Invoice #: ACM-01			
Site Name and NOI #: ACME Ute Gas Line and Water Disposal Line (NOI #: 2021-0002)		Legal Description: See map attached to approved NOI.

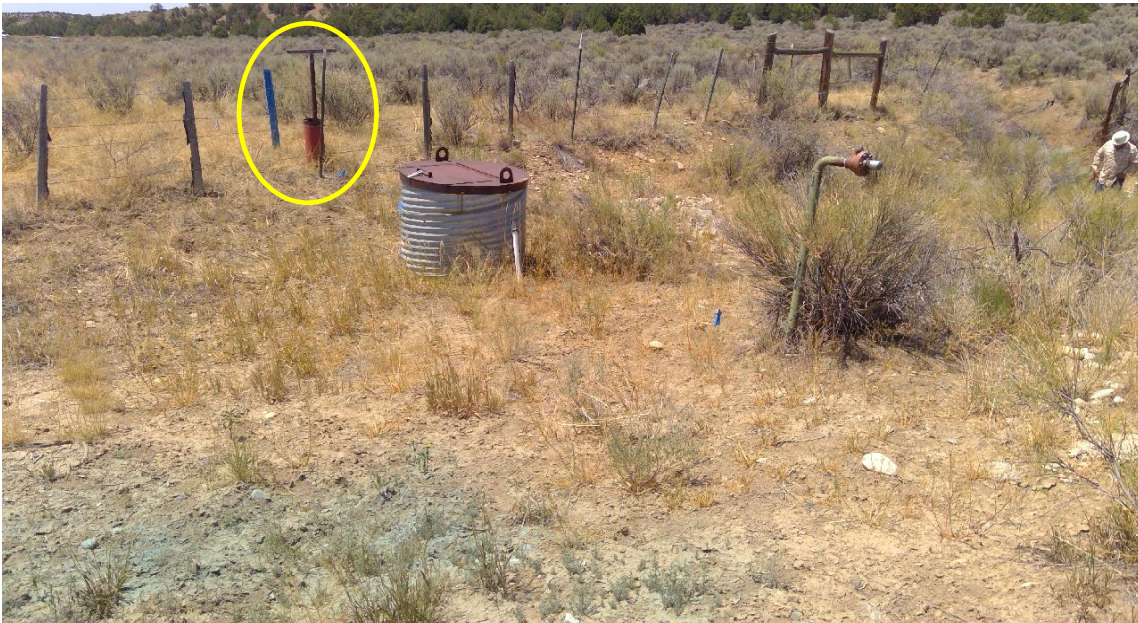
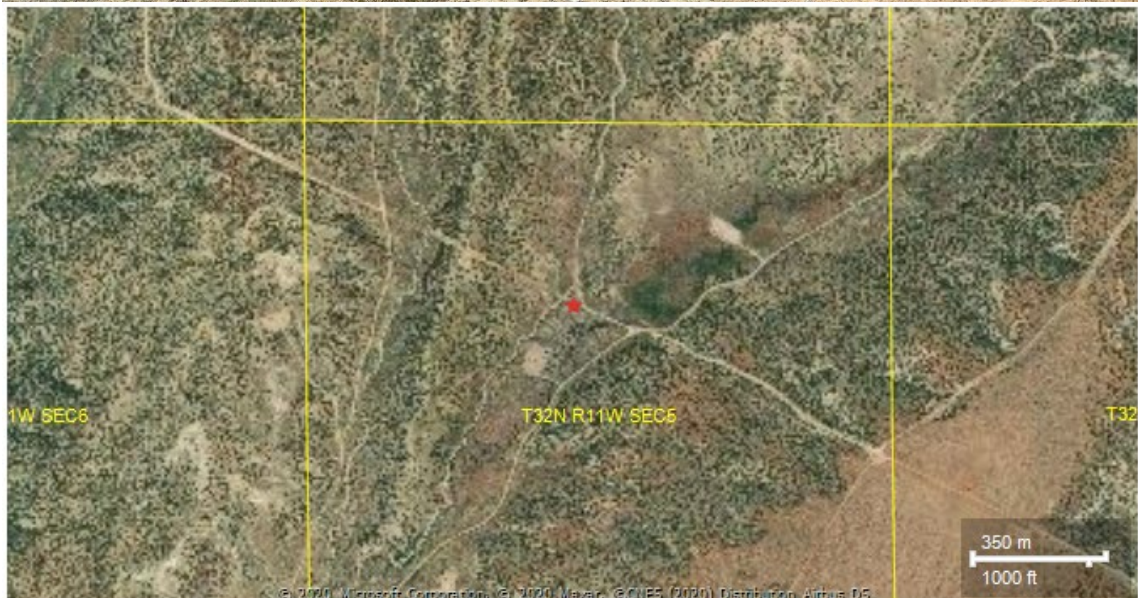
Lat/Long: 37° 2' 58.1064" E 108° 3' 58.0428" W (Approximate location of the image above.)

#1 Valve Can on ROW: One valve can is installed at the N end of the ROW where the "ACME Water Disposal Line" line ties into an operational trunk line. If possible upon removal of the valve can, DOE requests that the soil at the bottom of the valve can be segregated, placed into the bottom of the excavation made to cut/purge the pipeline/abandon the valve, and buried.

#1 Valve can (highlighted in yellow) remains installed on the ROW at the N end . Larger valve can is associated with an operational line and will not be abandoned.

DOE requests that the disturbance resulting from removing these appurtenances be seeded and mulched with the attached seed mix. The seeded and mulched areas will be monitored for at least one year for the presence of Colorado list A and B noxious weeds. Please provide all applicable documentation for this work as detailed in the pipeline abandonment checklist form (appurtenance removal photos, cut/cap photos, etc.).

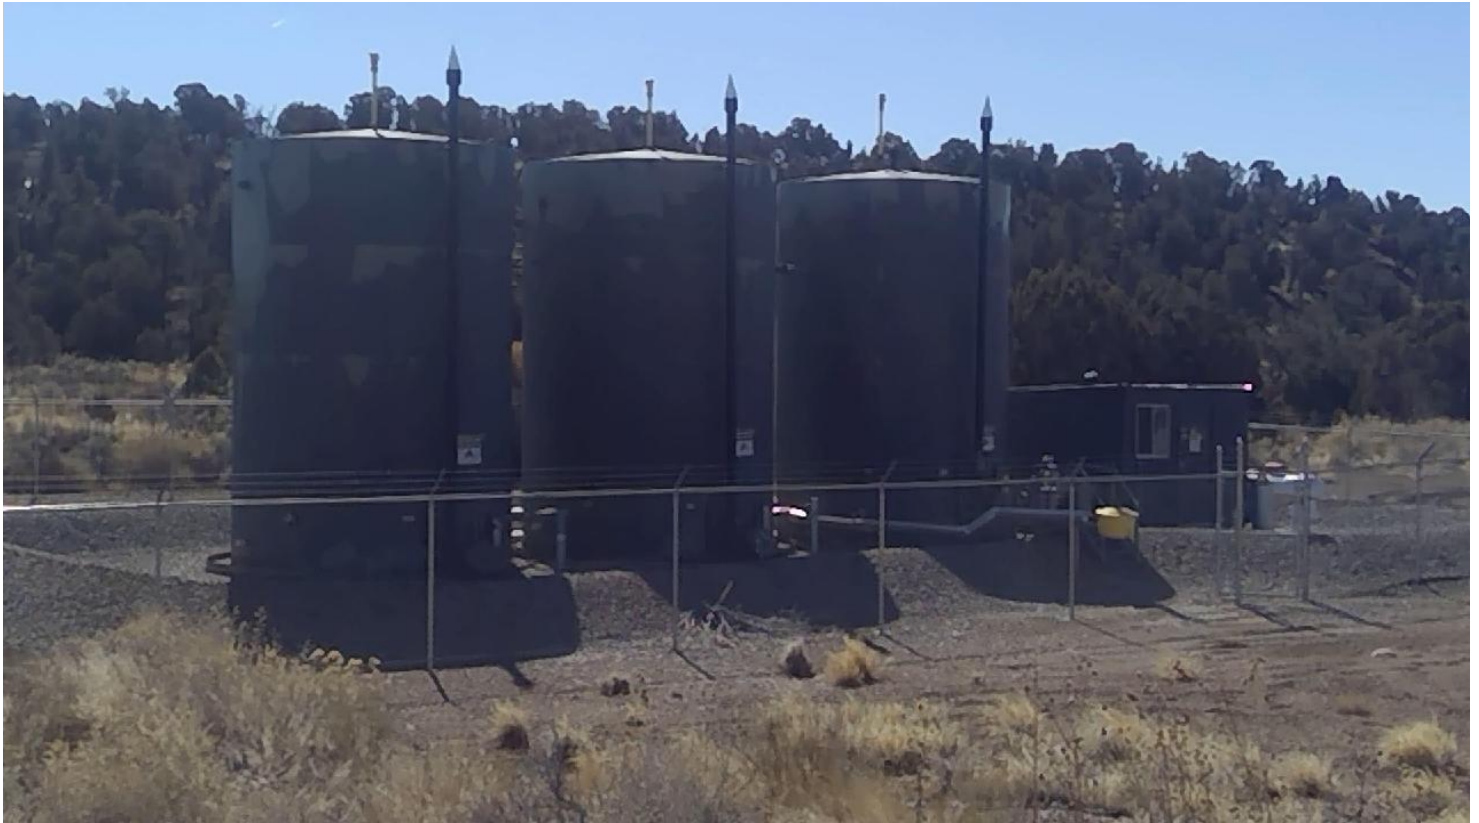
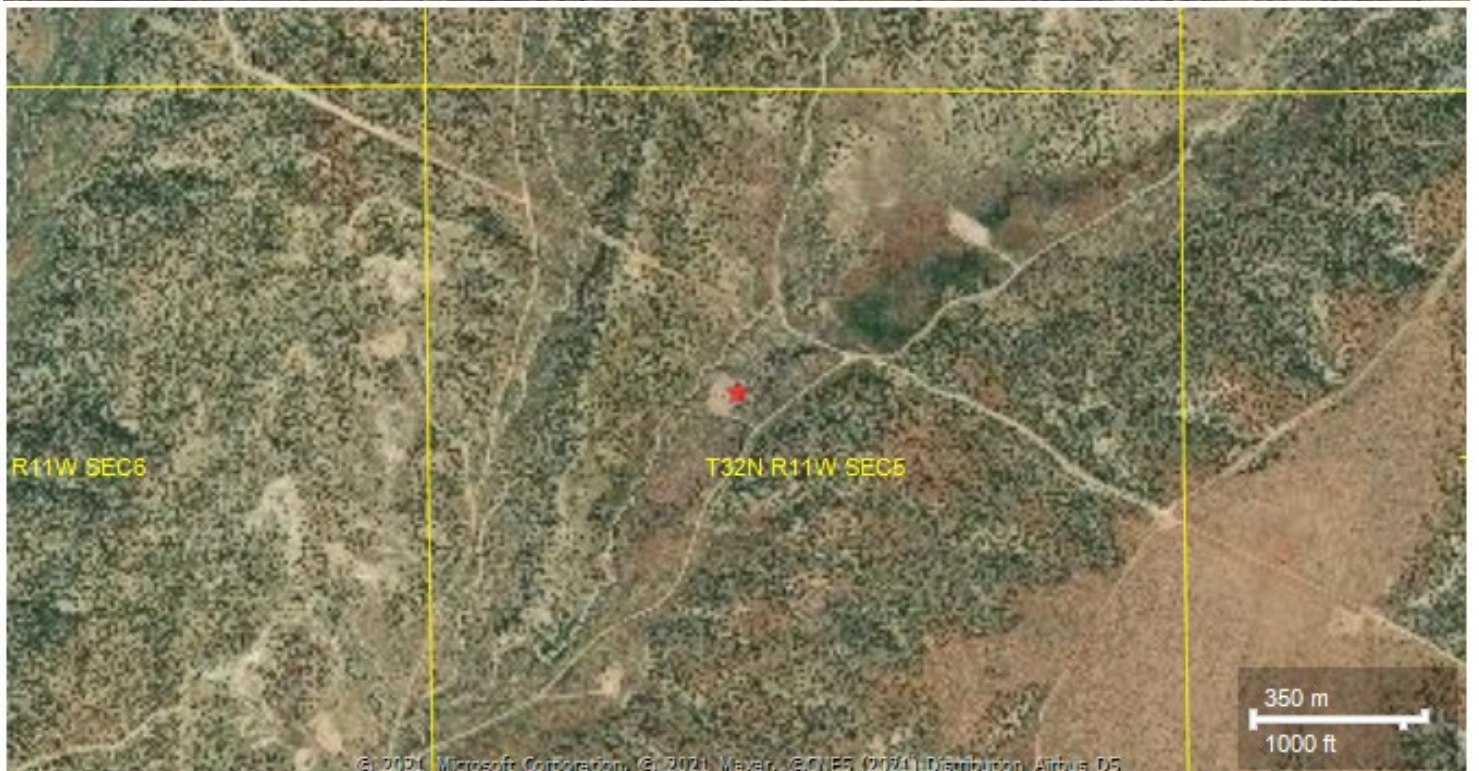
Lat/Long: 37°02'53.5"N 108°04'01.1"W (Approximate location of the images above.)

#2 Water Transfer Station Piping: Above ground piping at remains installed the S end of the line at the WTS and will be removed as part of this project.

#2 Line remains tied into the WTS tank battery.

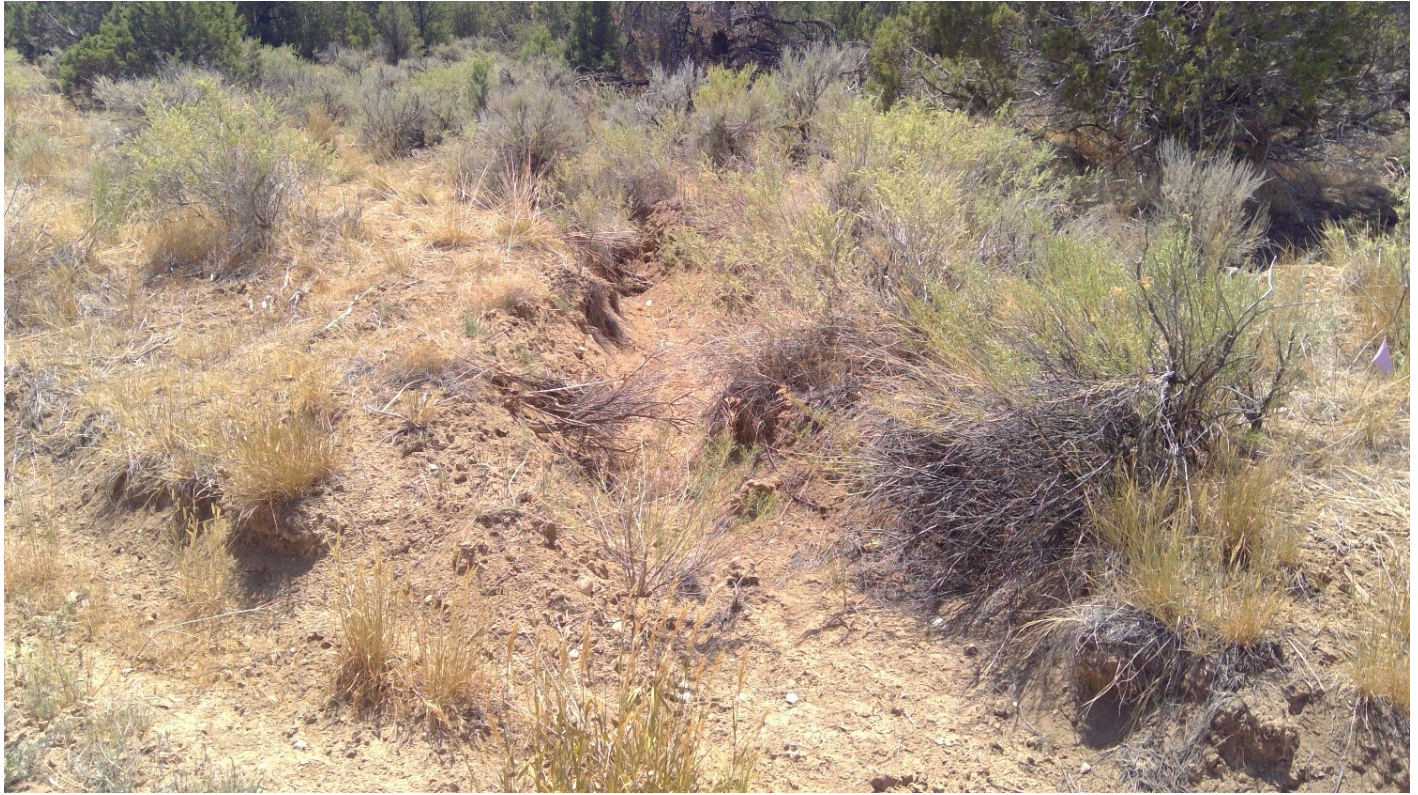
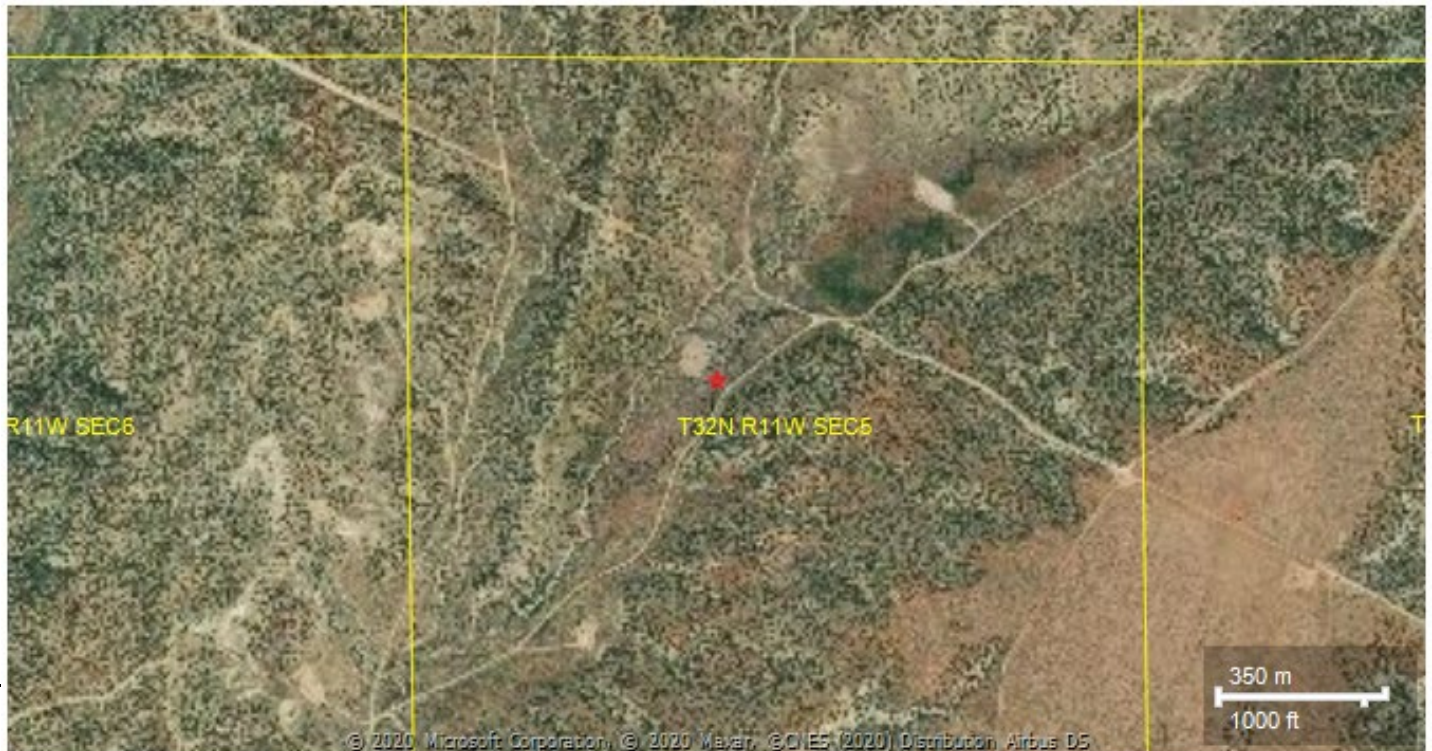
Lat/Long: 37° 2' 51.6444" E 108° 4' 0.3396" W (Approximate location of the image above.)

#3 Are there locations such as drainage crossings where pipeline depth will need to be verified? – The line to be abandoned in place is installed across one (1) ephemeral drainage. DOE requests that Acme provide verification that the pipeline is at least 30 inches below ground surface at the lowest point in the drainage.

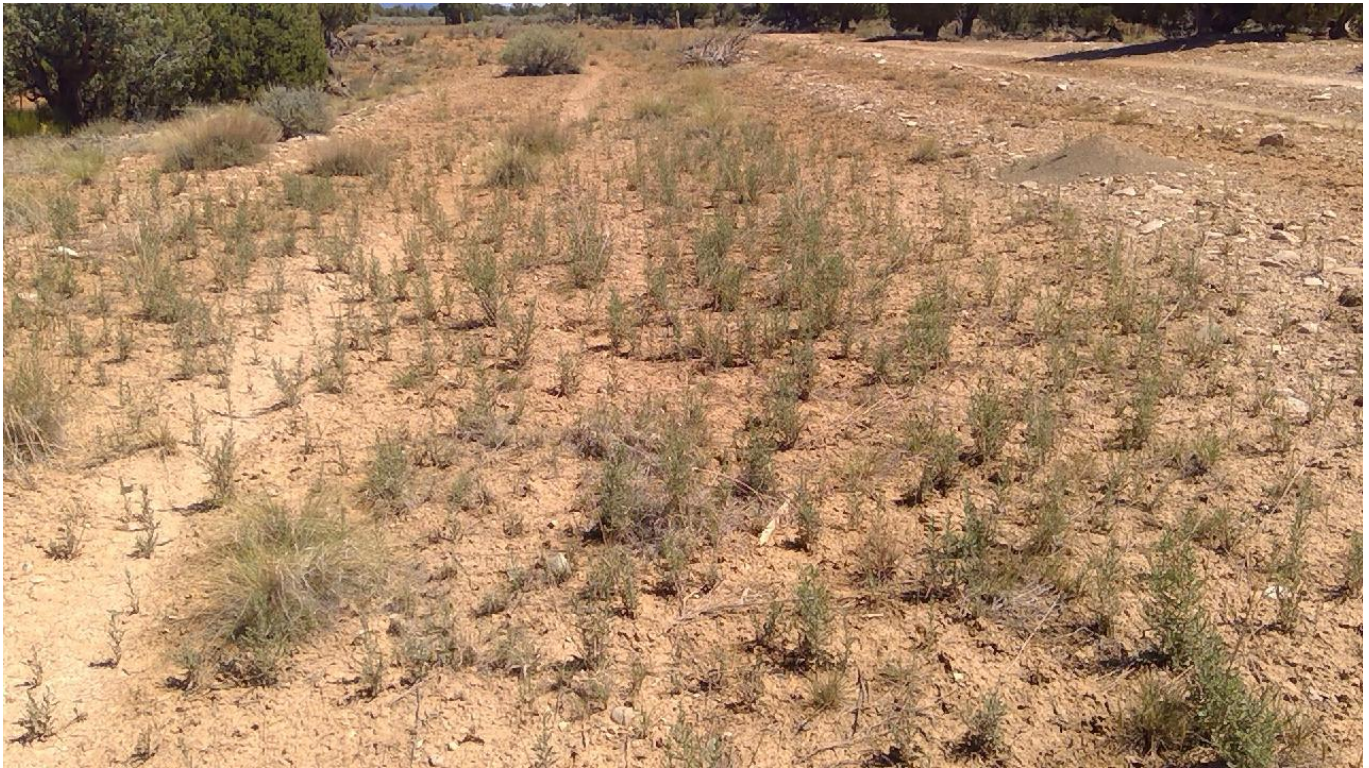
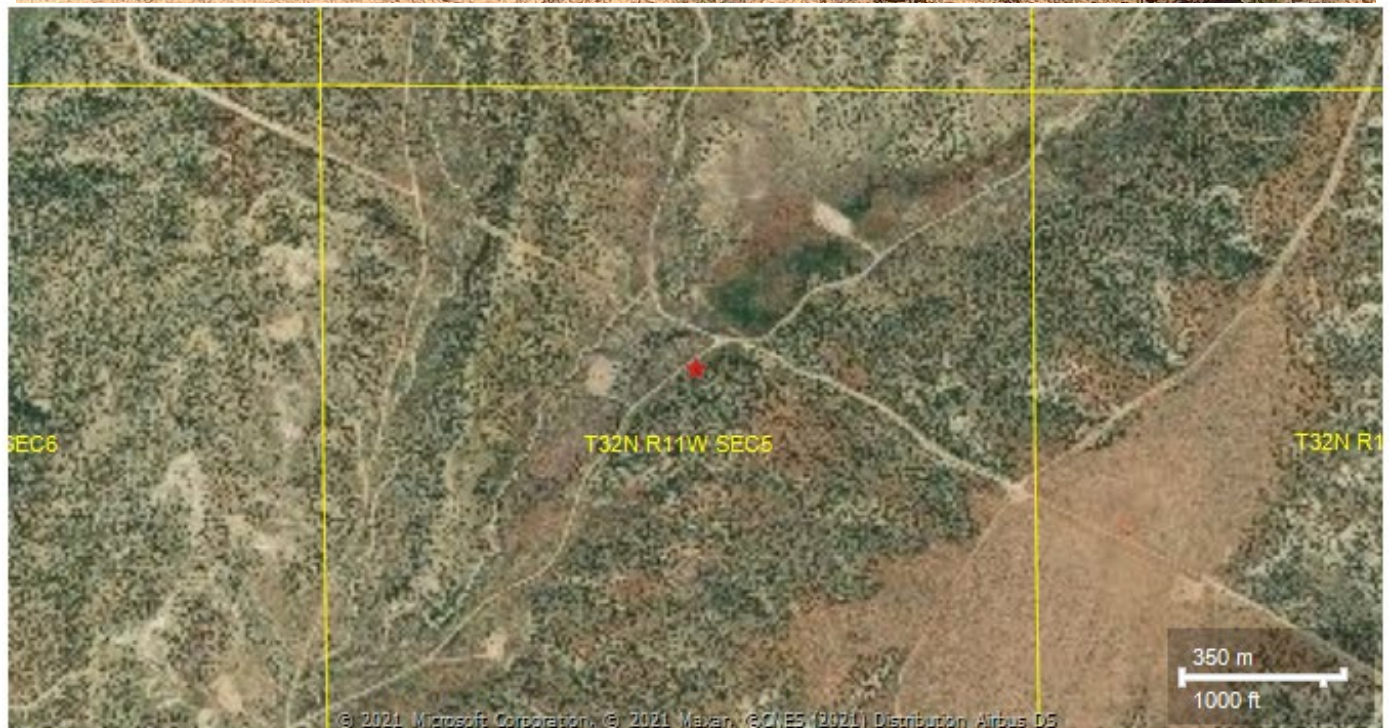
Lat/Long: 37°02'53.8"N 108°03'53.7"W (Approximate location of the images above.)

#8 Undesirable vegetation/noxious weeds controlled – A moderate infestation of Russian knapweed (*Acroptilon repens*) was observed to be developing on the ROW at the location detailed below. Russian knapweed is a Colorado List B species that requires control by the Colorado Commissioner of Agriculture. DOE recommends that Acme consult a licensed pesticide applicator to chemically treat the weeds at the most appropriate time. DOE requests that Acme provide documentation that the work has been completed. Documentation can come in the form of a spray log provided by the applicator or photos of the completed treatment if the herbicide application included a tank dye. As this infestation is isolated to the ROW and is not widespread to the adjacent undisturbed areas, DOE will monitor the management of this infestation for at least one year after the first treatment.
