Southern Ute Indian Tribe

Pipeline Abandonment Inspection Form

Inspector: John Doe, SUT DOE Environmental Compliance Specialist jdoe@sudoe.us Office #: 970-563-5544, Cell #: 970-769-8795	Date Inspected: 05/25/21	Operator: ACME Energy Co. Attendees: SUT DOE, SUT DNR		
Lease #: 750-88-1234	Pipeline Invoice #: ACM-01			
Site Name and NOI #: ACME Ute Gas Line and Water Disposal Line (NOI #: 2021-0002)	Legal Description: See map attached to approved NOI.

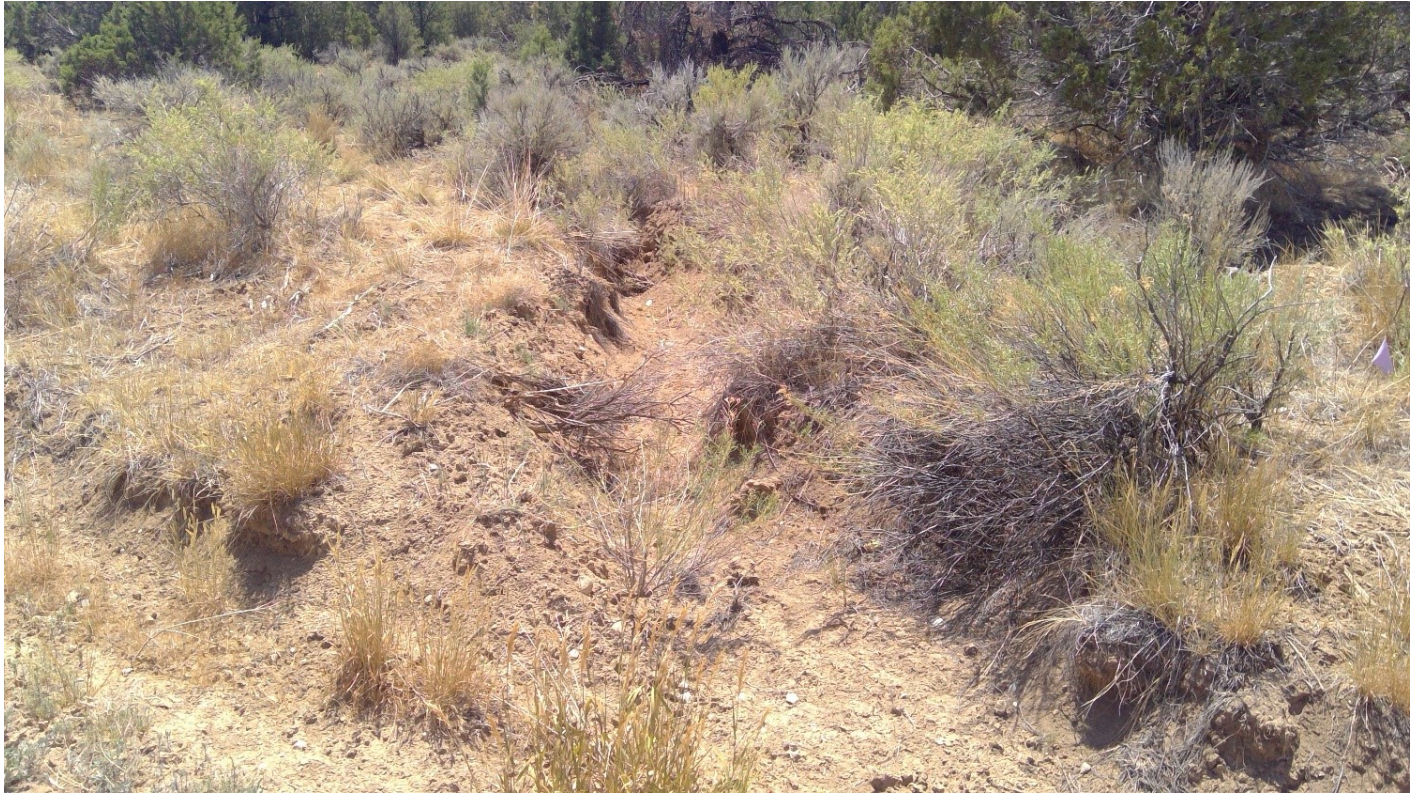
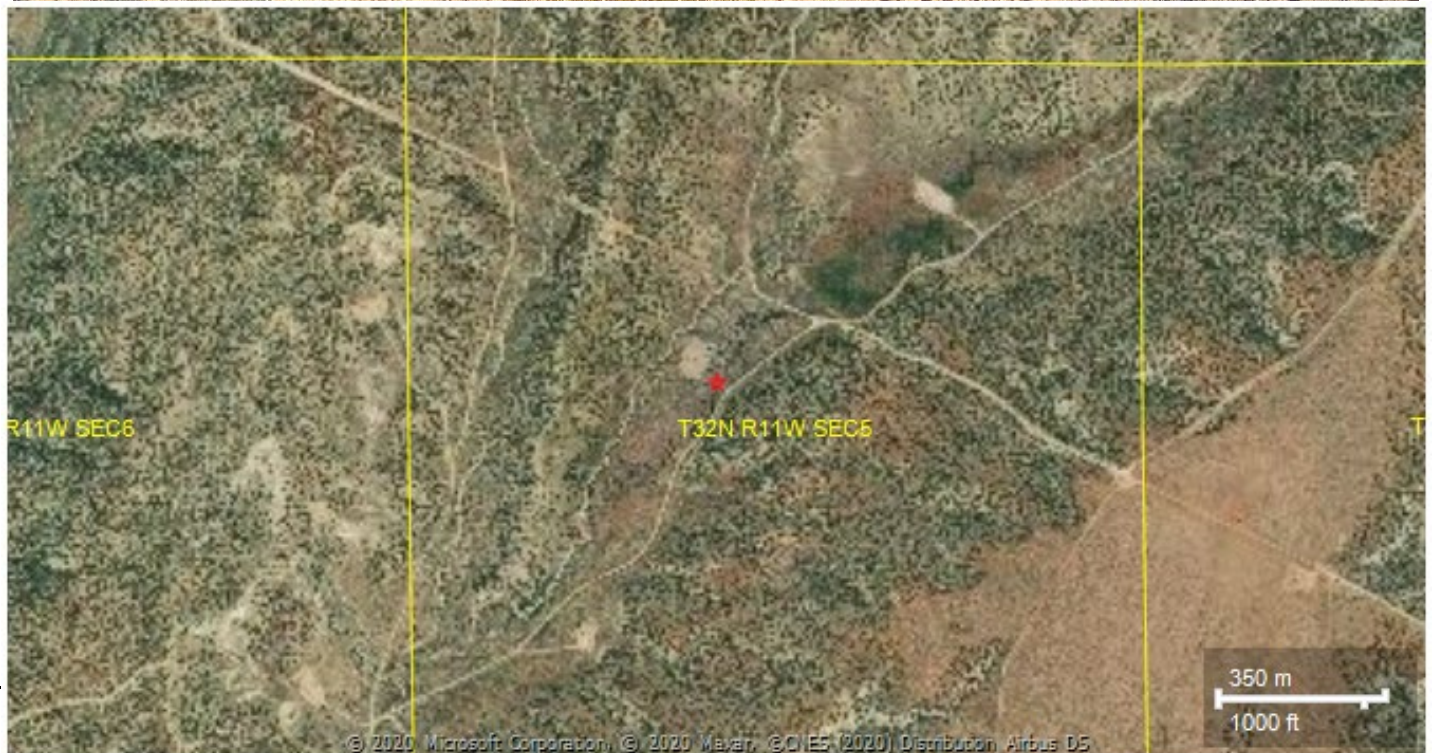
Lat/Long: 37° 2' 51.6444" E 108° 4' 0.3396" W (Approximate location of the image above.)

#3 Are there locations such as drainage crossings where pipeline depth will need to be verified? – The line to be abandoned in place is installed across one (1) ephemeral drainage. DOE requests that Acme provide verification that the pipeline is at least 36 inches below ground surface at the lowest point in the drainage.

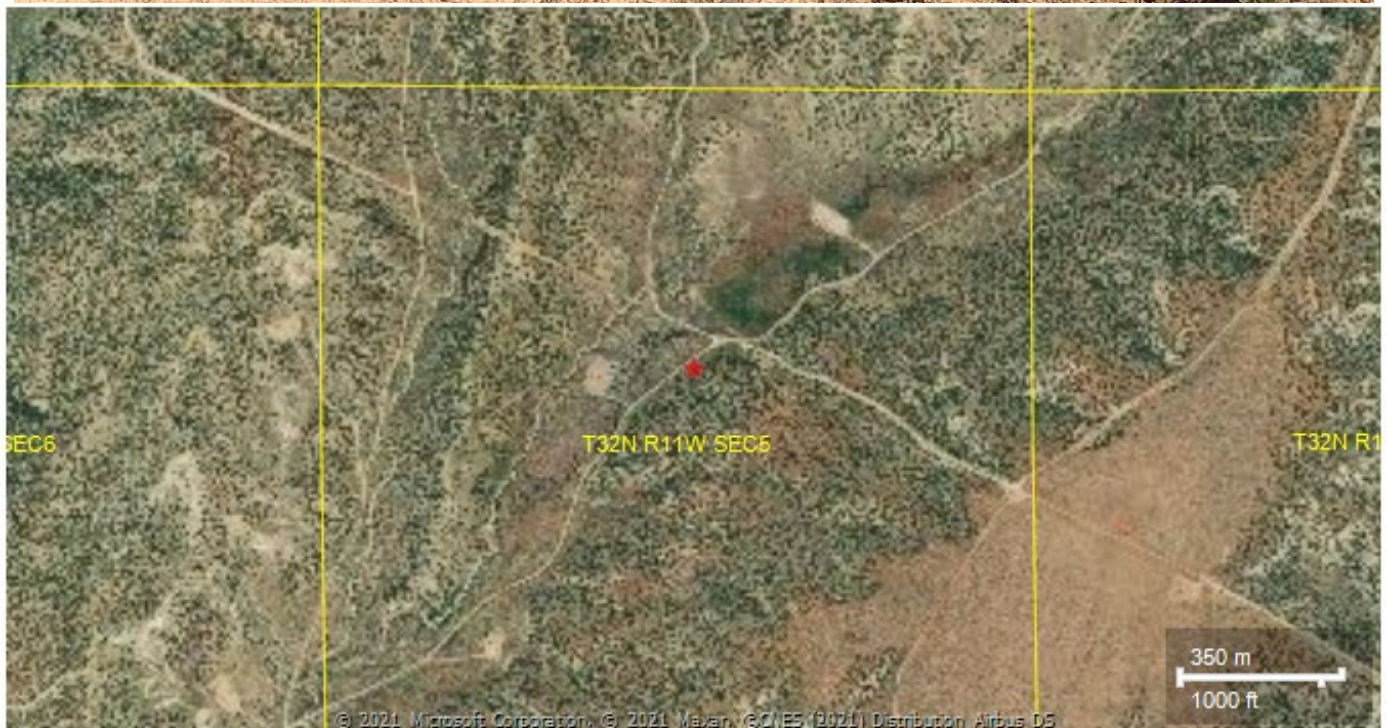
Lat/Long: 37°02'53.8"N 108°03'53.7"W (Approximate location of the images above.)

#8 Undesirable vegetation/noxious weeds controlled – A moderate infestation of Russian knapweed (*Acroptilon repens*) was observed to be developing on the ROW at the location detailed below. Russian knapweed is a Colorado List B species that requires control by the Colorado Commissioner of Agriculture. DOE recommends that Acme consult a licensed pesticide applicator to chemically treat the weeds at the most appropriate time. DOE requests that Acme provide documentation that the work has been completed. Documentation can come in the form of a spray log provided by the applicator or photos of the completed treatment if the herbicide application included a tank dye. As this infestation is isolated to the ROW and is not widespread to the adjacent undisturbed areas, DOE will monitor the management of this infestation for at least one year after the first treatment.
