Southern Ute Indian Tribe Pipeline Abandonment Inspection Form

Inspector: John Doe, SUIIT DOE Environmental Compliance Specialist jdoe@sudoe.us Office #: 970-563-5544, Cell #: 970-769-8795	Date Inspected: 12/03/2020, 12/04/2020	Operator: ACME Energy Co. Attendees: SUIIT DOE, SUIIT DNR
Project Name: Taylor Mesa Abandonment Project		
Lease #(s): 15-452-854-V, 14-20-151-34A	Pipeline Invoice #(s): TL-152, TL-10A, TL-189	
ROW Name(s): Area 1 Trunk, ACME 1 Well Tie, ACME 2 Well Tie	Legal Description: See map attached to the approved NOI for each ROW listed.

NOI #(s): 2020-0025, 2020-0026, 2020-0027

Narrative: The Southern Ute Indian Tribe (SUIT) Department of Energy (DOE) conducted a Pipeline Abandonment Inspection on the ACME Energy Company (ACME) “Taylor Mesa Abandonment” project area on 12/03/2021 & 12/04/2021. ACME will be abandoning the S portion of the pipeline system, largely in place. See corresponding approved NOI forms: 2020-0025, 2020-0026, 2020-0027 for additional details. Inspection Items #1, #3, & #8 were observed to be present/deficient during the inspection. See comments, photos, and maps below for additional details.

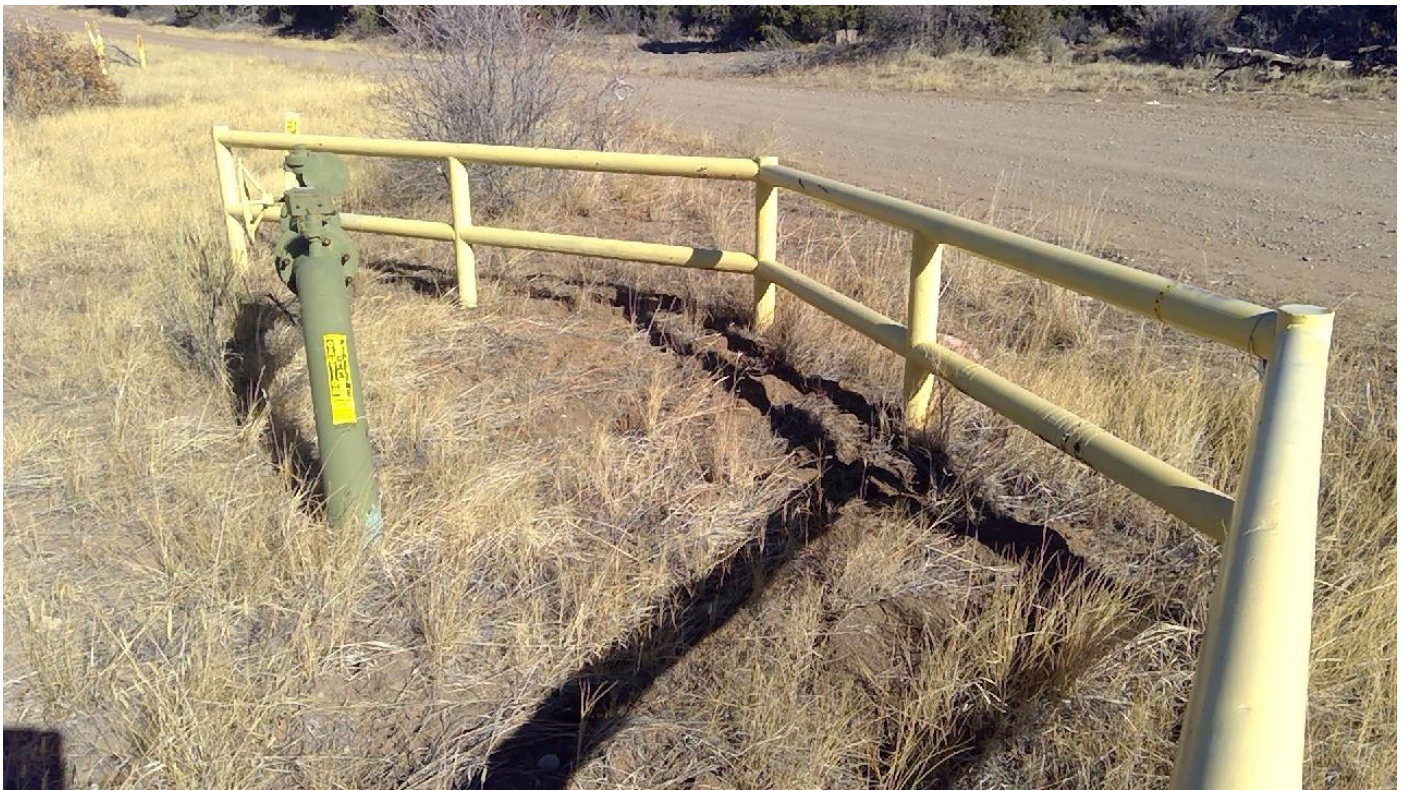
Issue location #: 1

Inspection Item: 1. Pipeline appurtenances present on ROW?

DOE Comments: One valve setting and metal barrier remains installed on the ROW at this location that will be fully removed. DOE requests that the disturbance resulting from removing this appurtenance/barrier be seeded and mulched with the attached seed mix. The seeded and mulched areas will be monitored for at least one year for the presence of Colorado list A and B noxious weeds. Please provide all applicable documentation for this work as detailed in the pipeline abandonment checklist form (appurtenance removal photos, cut/cap photos, etc.).

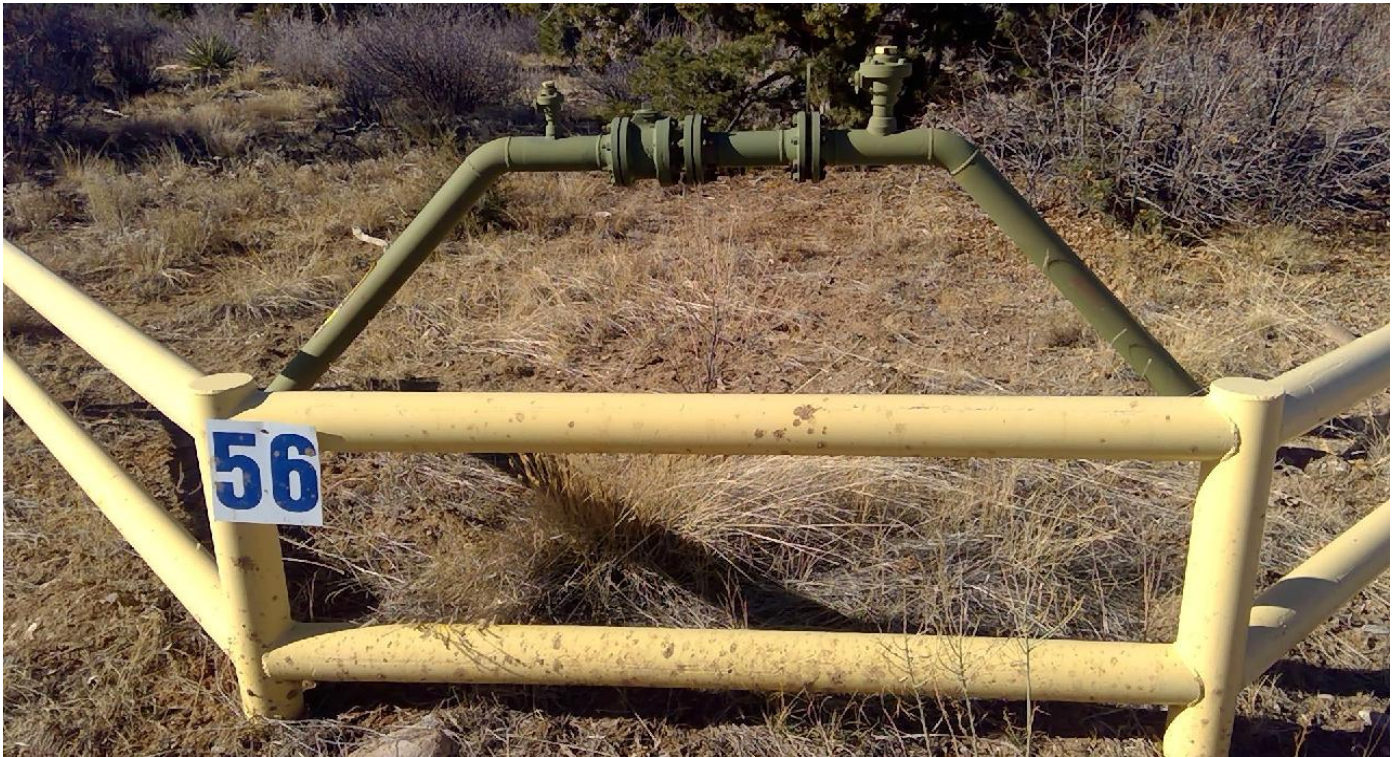
Issue location #: 2

Inspection Item: 1. Pipeline appurtenances present on ROW?

DOE Comments: One valve setting and metal barrier remains installed on the ROW at this location that will be fully removed. DOE requests that the disturbance resulting from removing this appurtenance/barrier be seeded and mulched with the attached seed mix. The seeded and mulched areas will be monitored for at least one year for the presence of Colorado list A and B noxious weeds. Please provide all applicable documentation for this work as detailed in the pipeline abandonment checklist form (appurtenance removal photos, cut/cap photos, etc.).

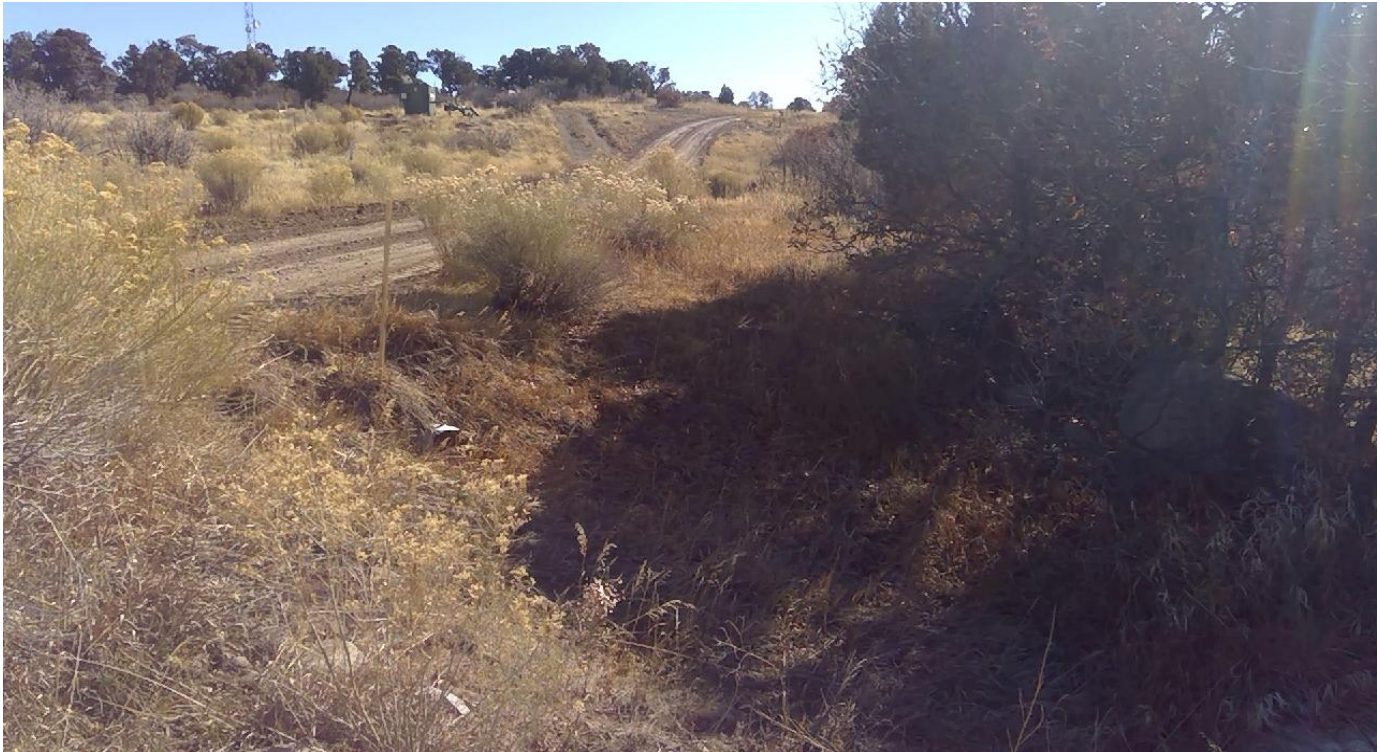
Issue location #: 3

Inspection Item: 3. Are there locations such as drainage crossings where pipeline depth will need to be verified?

DOE Comments: Three (3) pipelines are to be abandoned in place across an ephemeral drainage at the location detailed below. DOE requests that Acme provide verification that each of the pipelines are at least 30 inches below ground surface at the lowest point in the drainage.

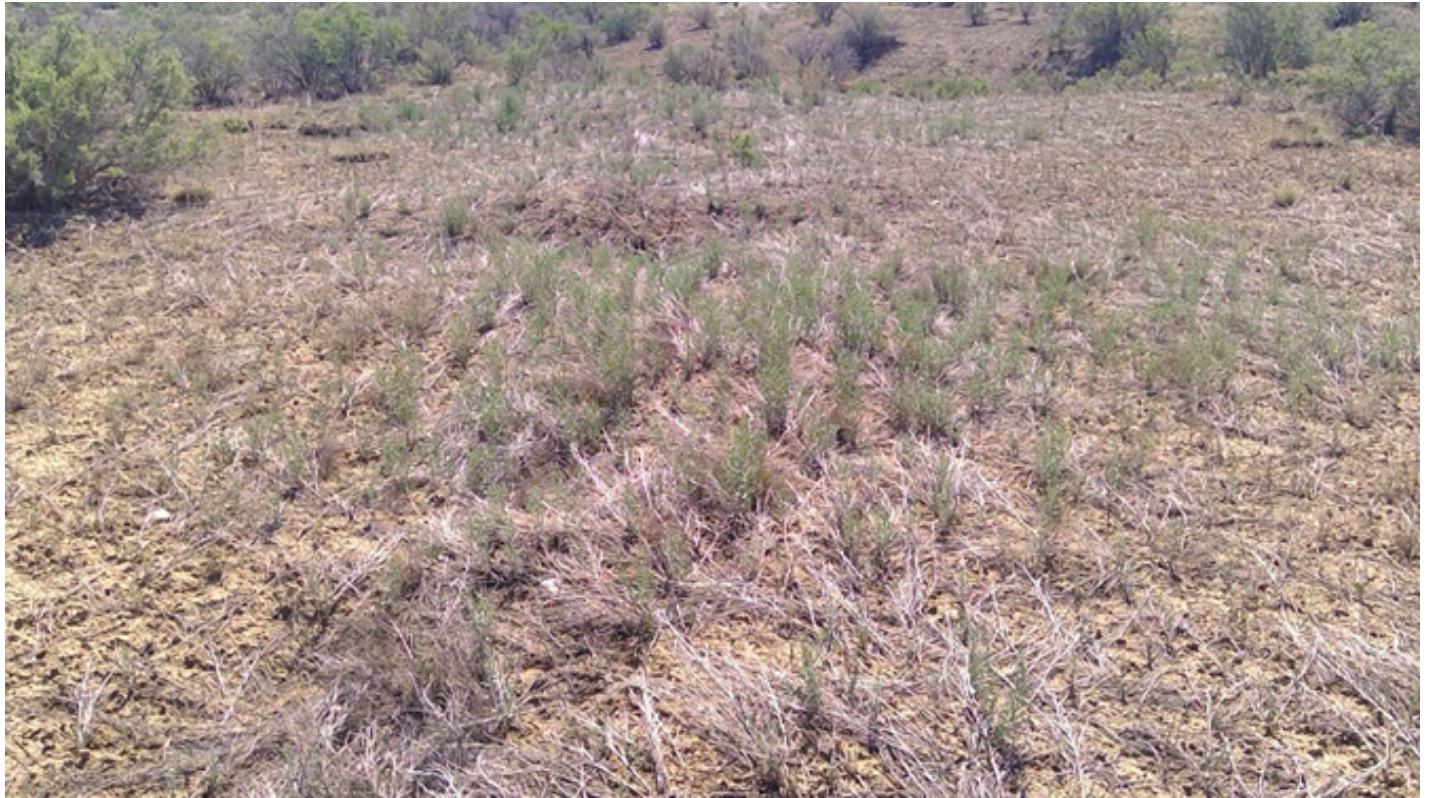
Issue location #: 4

Inspection Item: 8. Undesirable vegetation/noxious weeds controlled

DOE Comments: A moderate infestation of Russian knapweed (*Acroptilon repens*) was observed to be developing on the ROW at the location detailed below. Russian knapweed is a Colorado List B species that requires control by the Colorado Commissioner of Agriculture. DOE recommends that ACME consult a licensed pesticide applicator to chemically treat the weeds at the most appropriate time. DOE requests that ACME provide documentation that the work has been completed. Documentation can come in the form of a spray log provided by the applicator or photos of the completed treatment if the herbicide application included a tank dye. As these infestations are isolated to the ROW and are not widespread to the adjacent undisturbed areas, DOE will monitor the management of this infestation for at least one year after the first treatment.
