Southern Ute Indian Tribe Pipeline Abandonment Inspection Form

Inspector: John Doe, SUIT DOE Environmental Compliance Specialist jdoe@sudoe.us Office #: 970-563-5544, Cell #: 970-769-8795		Date Inspected: 12/03/2020, 12/04/2020		Operator: ACME Energy Co. Attendees: SUIT DOE, SUIT DNR	
Project Name: Taylor Mesa Abandonment Project					
Lease #(s): 15-452-854-V, 14-20-151-34A			Pipeline Invoice #(s): TL-152, TL-10A, TL-189		
ROW Name(s): Area 1 Trunk, ACME 1 Well Tie, ACME 2 Well Tie			Legal Description: See map attached to the approved NOI for each ROW listed.		
NOI #(s): 2020-0025, 2020-0026, 2020-0027

Narrative: The Southern Ute Indian Tribe (SUIT) Department of Energy (DOE) conducted a Pipeline Abandonment Inspection on the ACME Energy Company (ACME) "Taylor Mesa Abandonment" project area on 12/03/2021 & 12/04/2021. ACME will be abandoning the S portion of the pipeline system, largely in place. See corresponding approved NOI forms: 2020-0025, 2020-0026, 2020-0027 for additional details. Inspection Items #1, #3, & #8 were observed to be present/deficient during the inspection. See comments, photos, and maps below for additional details.

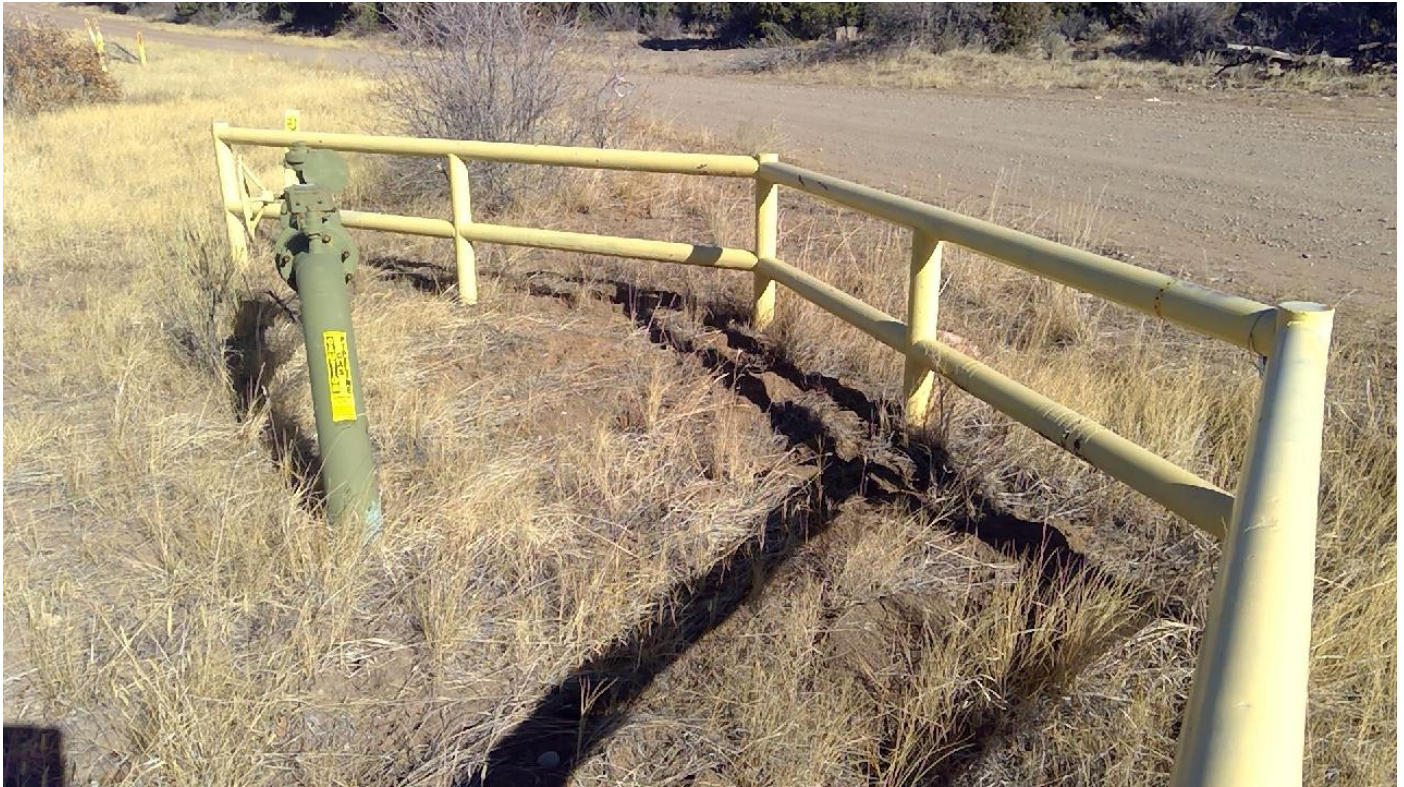
Issue location #: 1

Inspection Item: 1. Pipeline appurtenances present on ROW?

DOE Comments: One valve setting and metal barrier remains installed on the ROW at this location that will be fully removed. DOE requests that the disturbance resulting from removing this appurtenance/barrier be seeded and mulched with the attached seed mix. The seeded and mulched areas will be monitored for at least one year for the presence of Colorado list A and B noxious weeds. Please provide all applicable documentation for this work as detailed in the pipeline abandonment checklist form (appurtenance removal photos, cut/cap photos, etc.).

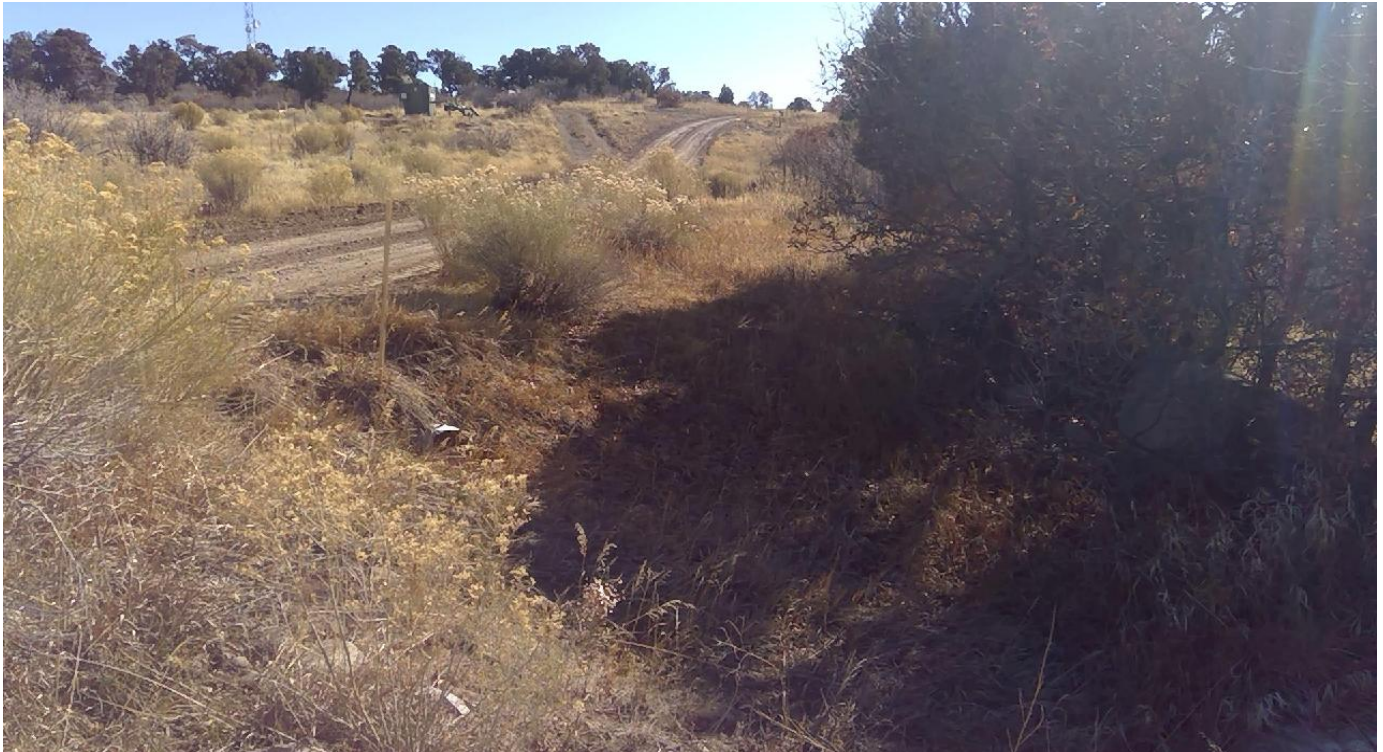
Issue location #: 3

Inspection Item: 3. Are there locations such as drainage crossings where pipeline depth will need to be verified?

DOE Comments: Three (3) pipelines are to be abandoned in place across an ephemeral drainage at the location detailed below. DOE requests that Acme provide verification that each of the pipelines are at least 36 inches below ground surface at the lowest point in the drainage.
